SUBJ: RCRA Compliance Evaluation Inspection  
Horsehead Metal Products, Inc.  
EPA ID# NCR000159038

## **RCRA Inspection Report**

**HORSEHEAD METAL PRODUCTS, INC.**

**COMPLIANCE EVALUATION INSPECTION PHOTOGRAPHS**

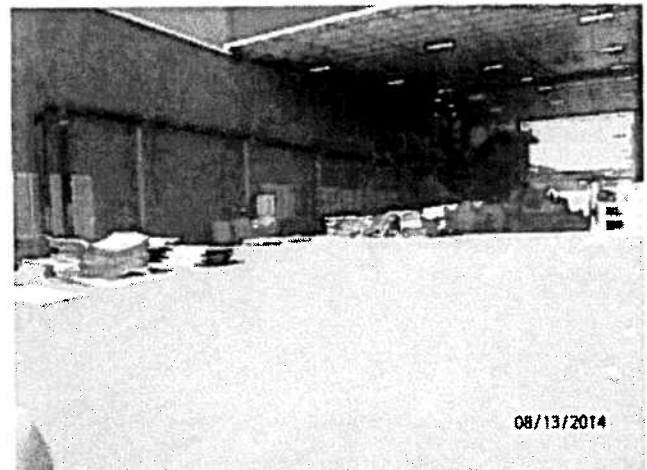
Picture 5 – Area 500 Furnace with stacks of zinc plates

The inspectors passed through the 500 Area (furnace) and 400 Area (electro-winning (EW)). The inspectors observed stacks of zinc plates being dried prior to being placing in the furnace (Picture 5); five 385,000-gallon electrolyte storage tanks with high zinc concentrate mixed with sulfuric acid solution (Picture 6) and the furnace baghouses (Picture 7). Mr. Harris explained that

The furnaces were designed to handle 16,500 pound bundles of zinc plates, stacked and placed inside (Pictures 5, 65). The zinc is melted and poured into molds for 25-pound and one-ton ingots. The ingots are sold to the steel industry for galvanizing uses, erosion protection of steel, the construction industry and the automotive industry. HHMP produces three products: prime western which contains 1% lead, continuous galvanizing grade which has 1.5% aluminum and a special high grade which is 99% zinc. Across from the Area 500 are four baghouses that capture the zinc dust from the furnace.

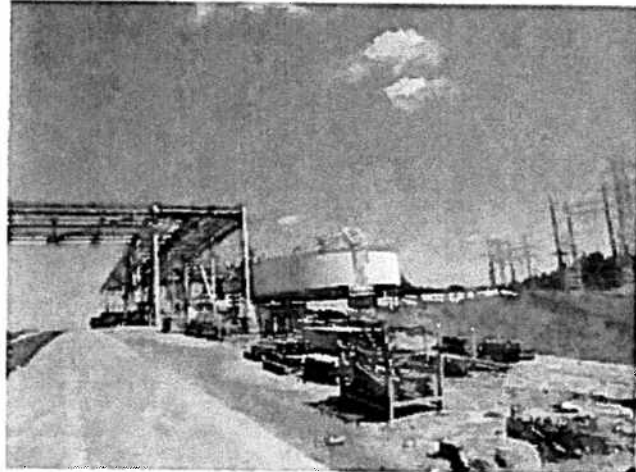
Picture 10 – WOX Clarifier

The WOX clarifiers mixes the WOX with water and sulfuric acid. The inspectors observed the clarifiers were open to the elements. The clarifiers and two stainless steel acid tanks were inside the secondary containment area (Pictures 10-11). At the time of the inspection, the gypsum clarifier (Pictures 17, 23), located downhill from the WOX clarifier, were experiencing blockage problems and were being pumped into the WOX clarifier secondary containment (Pictures 12-13). The inspectors observed that the secondary containment walls of the WOX clarifier had leaking cracks waiting to be repaired and areas that were newly resealed (Pictures 14-16). Mr. Harris explained that the secondary containment was designed to be a 10 to 14 day storage for process use.

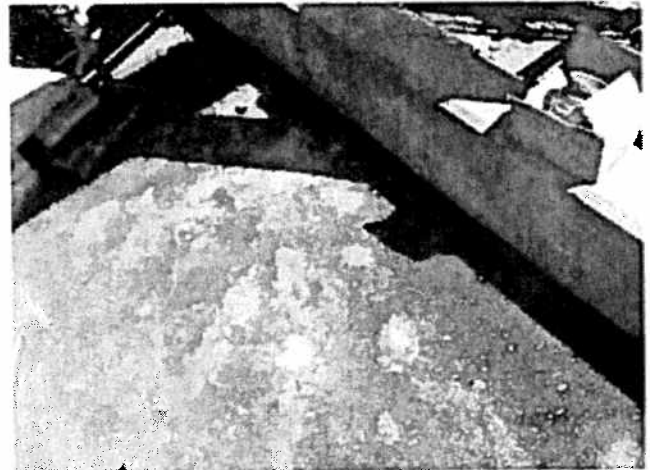
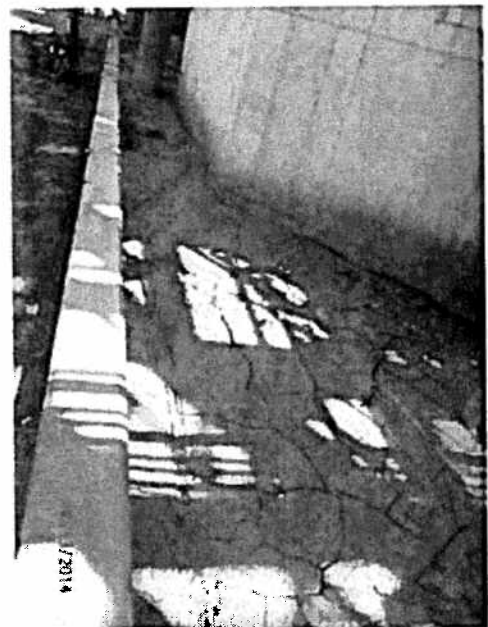
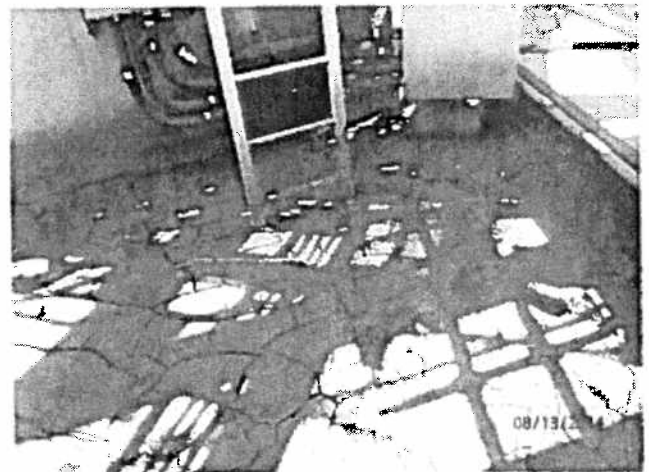
The Leaching Area contained a six-pack of reactors and a clarifier which are the core of the process. At the time of the inspection, Reactors A, B and E were down due to impellor failure because the interior coating had peeled off. The WOX mixture, known as the leaching slurry, added to the reactors from the silos were released to the secondary containment. The inspectors observed that the leaching slurry had dried into a thick and cracked mud and was being walked through by the employees. Leaching slurry residue was seen on the outside of the reactor tanks, on the top of the reactor secondary containment walls, and inside the 100 Area secondary containment (Pictures 24-34).

Picture 28 – Area 100 Leaching dried WOX mixture on the ground

Picture 29 – Area 100 Leaching WOX mixture released to the secondary containment

Picture 32 – Area 100 Leaching WOX mixture residual dried on the wall

Picture 34 – Area 100 Leaching WOX mixture residual dried on the ground

NCDENR recommended that the HHMP use at least one of the reactor tanks as backup for sudden releases and storage of the leaching slurry. The inspectors also recommended that the leaching slurry already released and stored into the secondary containment be cleaned out and stored into roll-offs and/or containers, which would allow HHMP to pump the slurry back into the reactor tanks. The inspectors understand that HHMP considers the leaching slurry to be a "product-in-process". However the slurry release had been stored in the reactor secondary containment for three weeks, there were footprints from employees and contractors walking through the slurry and the slurry residue was observed outside the reactor secondary containment walls. The EPA advised Mr. Harris and Mr. Scott Hoenecke, Operations Manager, that the leaching slurry contained hazardous constituents (including lead, cadmium and chromium) and releasing the slurry into the secondary containment was not considered to be in-process or to be properly stored and/or contained. The EPA recommends that the slurry be stored in appropriate containers until such time that it can be used in the process.

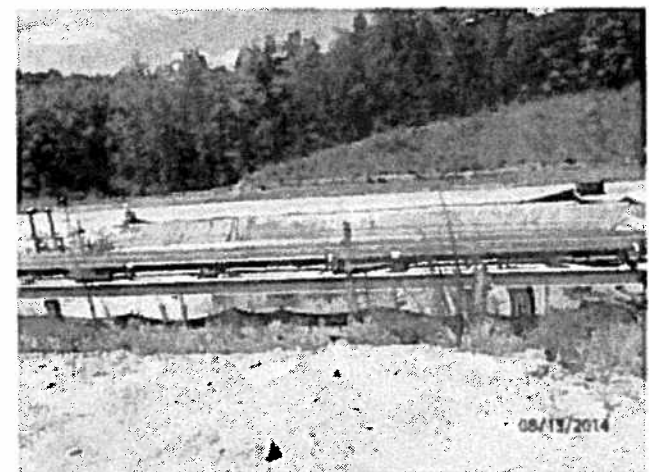
Picture 41 – Area 200 Process Ponds

The Area 200 contained the processes for zinc electrolyte solution phase separation (Picture 39). The inspectors observed black tanks used to separate water from the zinc, acid and organic solvent solution. Behind the tanks were the process ponds, a maintenance pond, and the West Storm Water Pond (Pictures 40-43). Mr. Harris explained that the zinc raffinate goes, via a green pipe, into the open process ponds. Next was a maintenance pond with orange water. The last pond was the West Storm Water Pond with geese deterrents. This pond was lined for acidic organic solutions and contained acidic water with a red algae bloom. Mr. Hoenecke explained that this pond acts as a catchall from the process areas. The process water came from tank failures and coating failures in the process tanks.

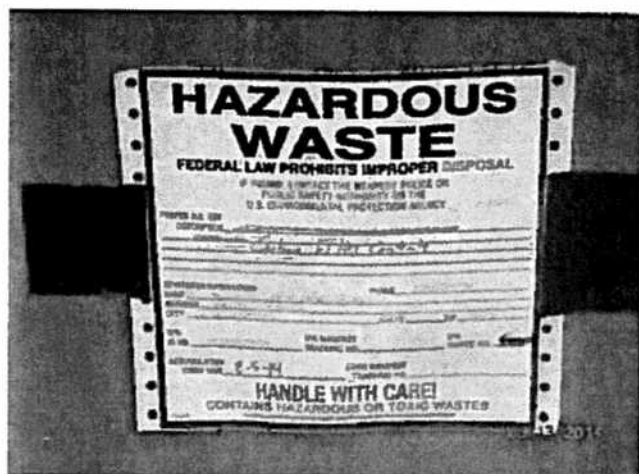
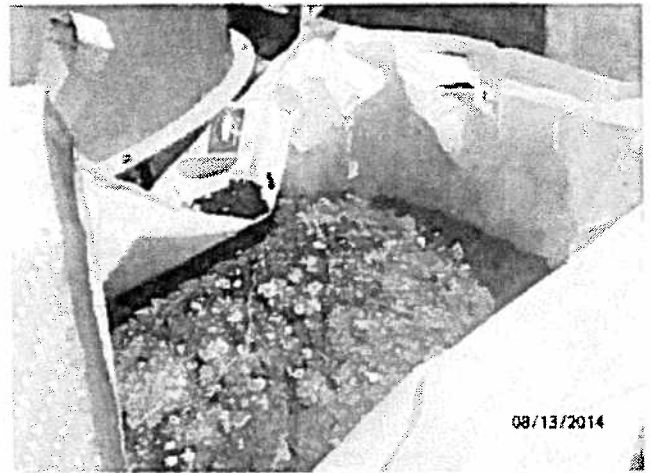
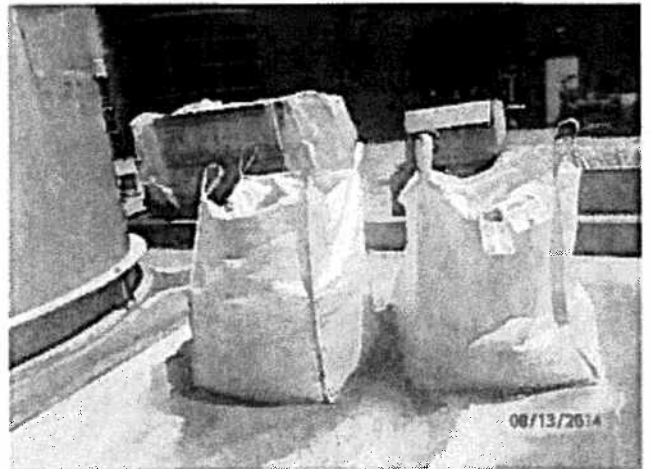
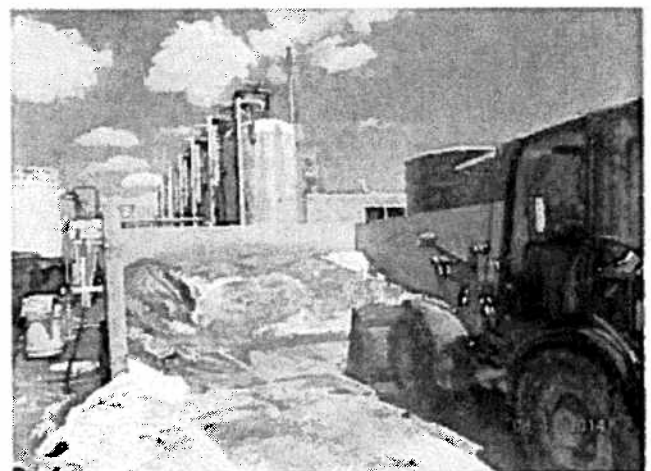
While leaving Area 200, the inspectors observed hazardous waste roll-offs (Pictures 44-55). The four blue roll-offs were observed labeled for “Carbon Filter Contents”, closed and dated. Beside the roll-offs were seven carbon filter tanks with electrolyte filters. At the time of the inspection, the filter tanks were shut down for a first time emergency cleanout due to equipment failure. Two white super sacks were observed in the secondary containment area of the carbon filter tanks. Mr. Harris was asked about the contents of the sacks but could not identify their source. Mr. Hoenecke later explained that the sacks were from carbon filter clean out and required discarding. The super sacks were open, unlabeled and not dated.

In front of the carbon filter tanks was a decontamination bay used for equipment clean out. At the time inspection, a pile of discarded carbon from the carbon filter tanks were inside the bay waiting to be frontloaded into roll-offs. Mr. Harris explained that the discarded carbon had a sample tested using the toxicity characteristic leaching procedure (TCLP). The discarded carbon had a TCLP result of 6.5 ppm of lead which exceeded the regulatory limit of 5.0 mg/L. Therefore, the discarded carbon was uncontained, unlabeled and undated hazardous waste.

**Horsehead Metal Products, Inc. is in apparent violation of 15A NCAC 13A.0107 [40 C.F.R. § 265.173(a)] as referenced in 40 C.F.R. § 262.34(a)(1)(i)], which states, except as provided in paragraphs (d), (e), and (f) of this section, a generator may accumulate hazardous waste on-site for 90 days or less without a permit or without having interim status, provided that the waste is placed in containers and the generator complies with the applicable requirements of subpart I of part 265 of this chapter in such that a container holding**

**hazardous waste must always be closed during storage, except when it is necessary to add or remove waste.**

**Horsehead Metal Products, Inc. is in apparent violation of 15A NCAC 13A.0107 [40 C.F.R. § 262.34(a)(2) and (a)(3)]. Except as provided in paragraphs (d), (e), and (f) of this section, a generator may accumulate hazardous waste on-site for 90 days or less without a permit or without having interim status, provided that the date upon which each period of accumulation begins is clearly marked and visible for inspection on each container; and while being accumulated on-site, each container and tank is labeled or marked clearly with the words, "Hazardous Waste".**

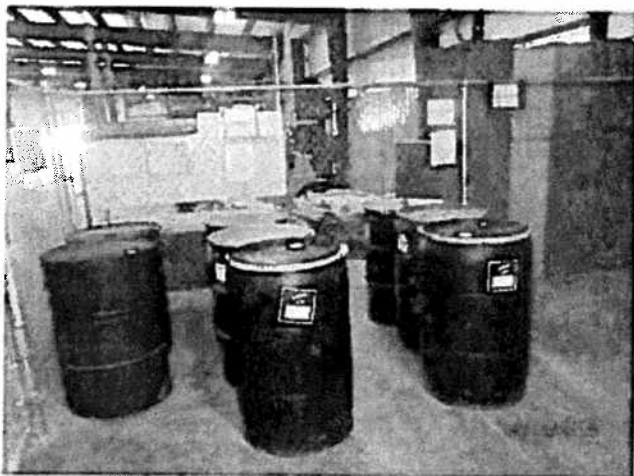
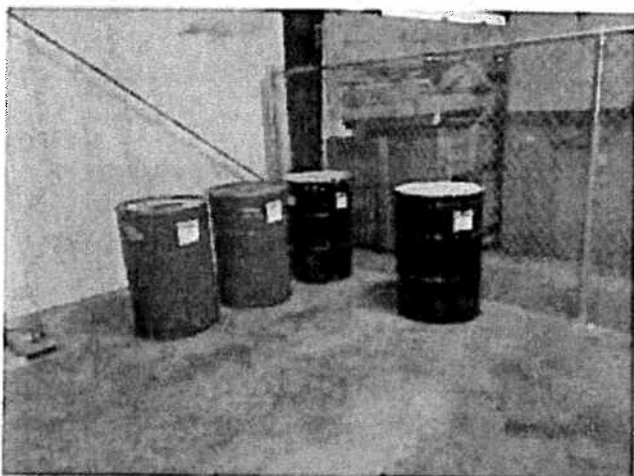
The less than 90-day hazardous waste storage area (HWSA) is located in the Area 500 warehouse. The inspectors observed a fenced-in area that was locked and marked with warning signs. Inside the enclosure was seven 55-gallon drums of used oil, oily water, oily rags and oily cleanup, and four black 55-gallon drums containing xylene and methyl ethyl ketone; solvent contaminated rags; flammable liquid; and acetone and methanol. The drums were observed labeled, closed and dated (Pictures 66-69).

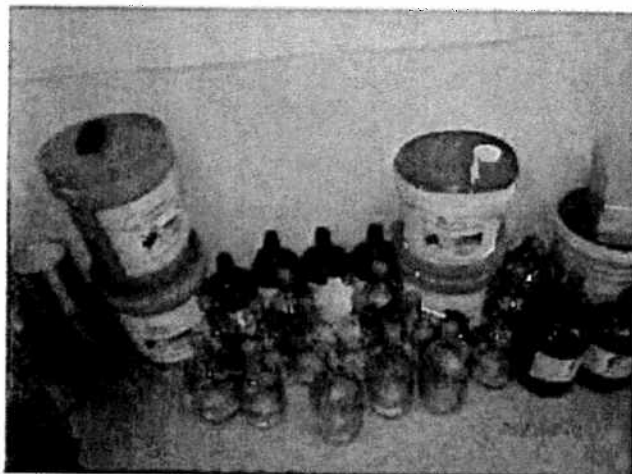
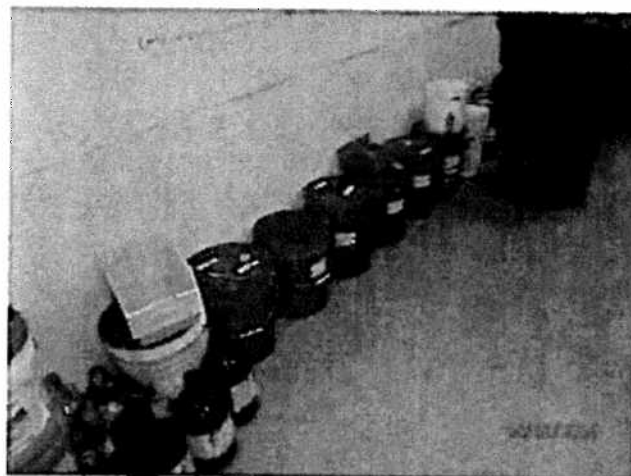
Picture 71 – Lab RCRA empty bottles

release. The lab stored empty bottles and containers along the walls for reuse and recycling (Pictures 71-72).

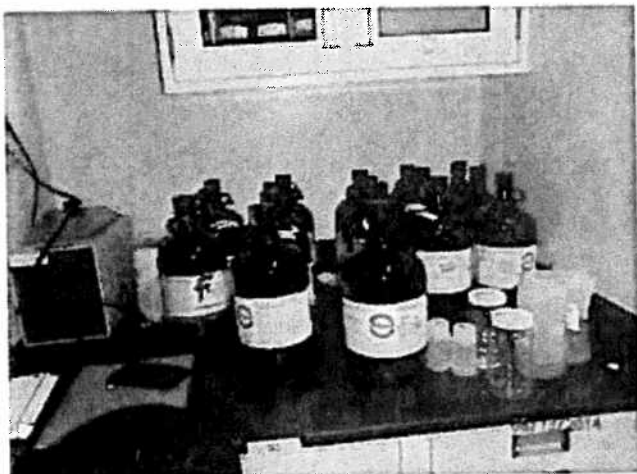
Picture 73 – Lab used TCE solvent recycling area

The second lab distilled used trichloroethylene (TCE). The inspectors observed a counter with used TCE bottles (Picture 73). The technician explained the used TCE was considered “waste in process” and would be recycled when it was no longer usable. The inspectors advised that the lab technicians monitor the volume of used TCE on the counter and ensure that the volume stay under 55-gallons.

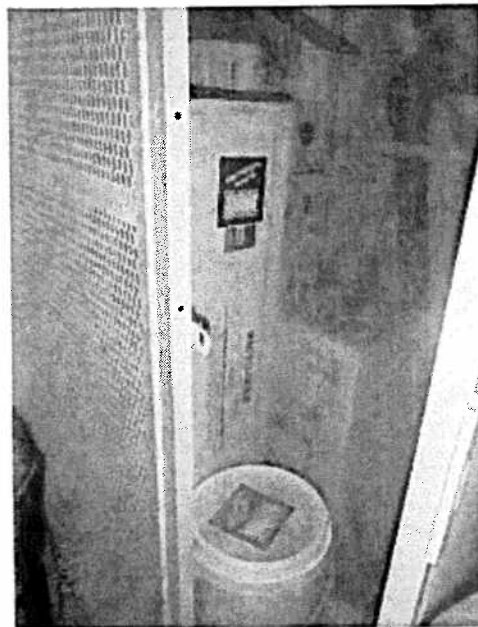
The Maintenance Area contained two 55-gallon used oil drums, one with a funnel on top; a red flip-top flammable can used for oily rags and a universal waste storage cabinet (Pictures 74-77). At the time of the inspection, the inspectors observed that the boxes of universal waste lamps were labeled, closed but not dated.

**Horsehead Metal Products, Inc. is in apparent violation of 15A NCAC 13A.0119(b) [40 C.F.R. § 273.15(c)], which states that a small quantity handler of universal waste who accumulates universal waste must be able to demonstrate the length of time that the universal waste has been accumulated from the date it becomes a waste or is received.**
